SY WITCH

Supplementary report on
strengthening the mast support as
well as various clarifications as of
August 19, 2014

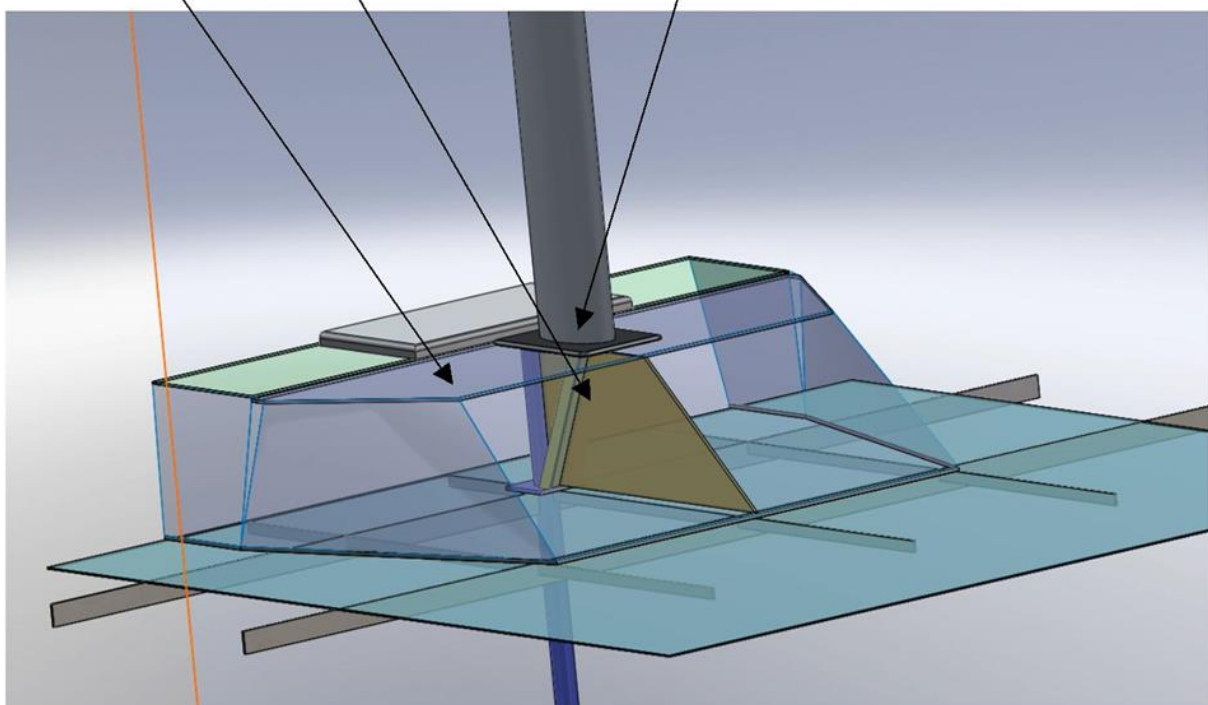
As a result, the force distribution on the mast support running below deck on the keel became asymmetrical and unfavourable.

This resulted in a deformation of the upper structure and absolutely had to be corrected.

Reinforcement was necessary to ensure the correct introduction of force into the existing structure. The rig was therefore removed again, the upper structure was cut open and a reinforcing middle plate (8mm) with T-reinforcement on both sides (40*40*5 mm) was installed according to the sketch below. The top plate was replaced with a stronger, thicker plate (8 mm)

The compression forces of the mast are absorbed by the middle plate and guided to the existing mast support using the T-reinforcements on both sides

In summary, it can be stated that the introduction of a mast support was absolutely necessary. The chosen design created an extremely stable substructure and the force curve of the mast forces was corrected.
